Manhole Inspection Summary

Manhole # S41QQ_033MH

Location Address: **2511 AISQUITH AVE**

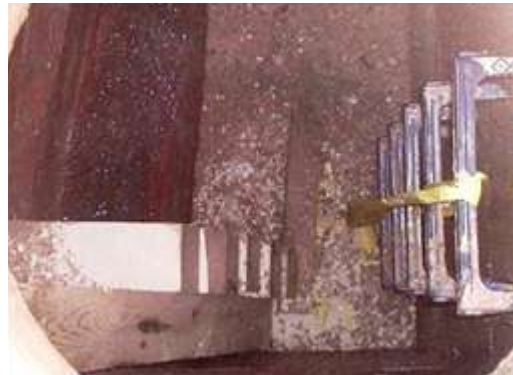
Top View

Bench debris.

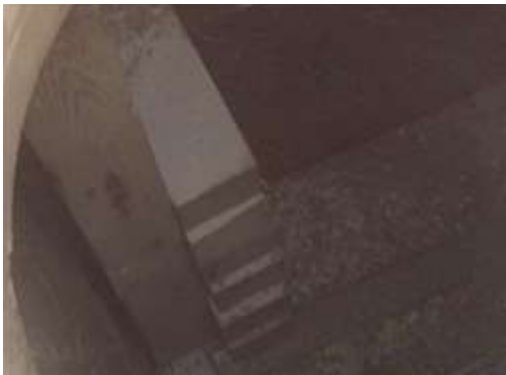
Comments **There is construction all around inside the MH. A huge piece of wood is blocking the i6 pipe.**

Wood barrier over the I6

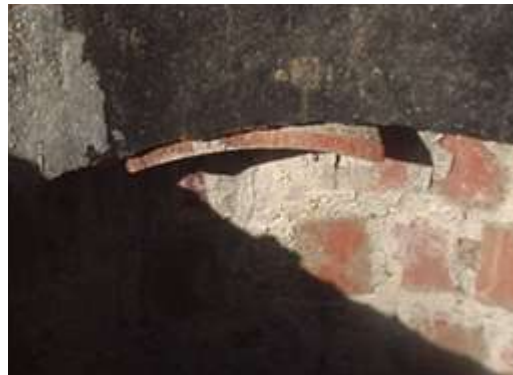
Defect

Condition: ☐ Sound ☐ Cracked ☐ Root Intrusion ☒ **Loose Brick** ☒ **Deteriorated**

Infiltration: ☐ None ☒ **Joint** ☐ Cracks ☐ Mortar ☐ Roots ☒ **Wall**

Adjustment deterioration, loose brick and infiltration.
